## Fort Campbell Childers House

Historic Maintenance and Repair Manual

September 2006

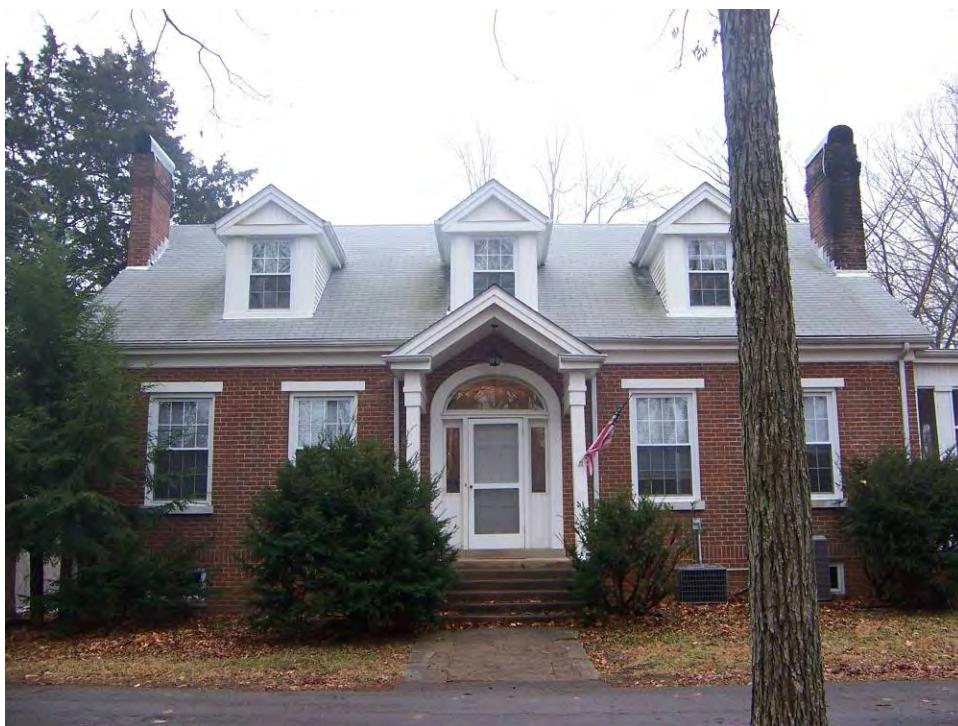
**Figure 2. West (front) facade.**

Overall, the west (front) facade is a Level 1 (Preservation Zone), the windows are a Level 4 (Free Zone), and the aluminum covered wood details and missing shutters are a Level 6 (Impact Zone). Areas that need the most attention are the front facade and chimneys, as well as improperly installed gutters and downspouts. These areas are of significant historic value and Directorate of Public Works (DPW) should maintain them. Mold and lichen growth needs to be removed from the brick and mortar, the brick and mortar cleaned, and the mortar repointed to prevent further deterioration. Any missing elements, such as the green shutters should be replaced in-kind. Care should be taken in the repair of the brick walls with materials as near to the original color as possible and with similar mechanical properties as the original brick and mortar. Areas that need attention on the Childers House are, but not limited to, the brick walls and mortar; the asphalt roof; the chimneys and their components; and the overgrown vegetation.

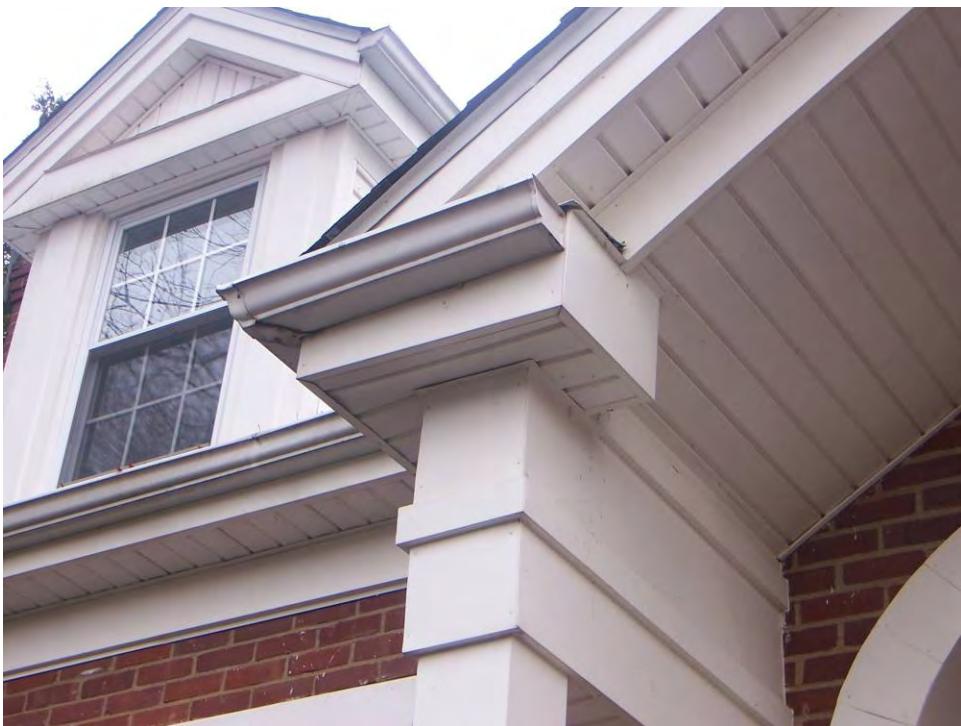
Figure 20. Aluminum covering original porch columns, fascia, and ceiling.

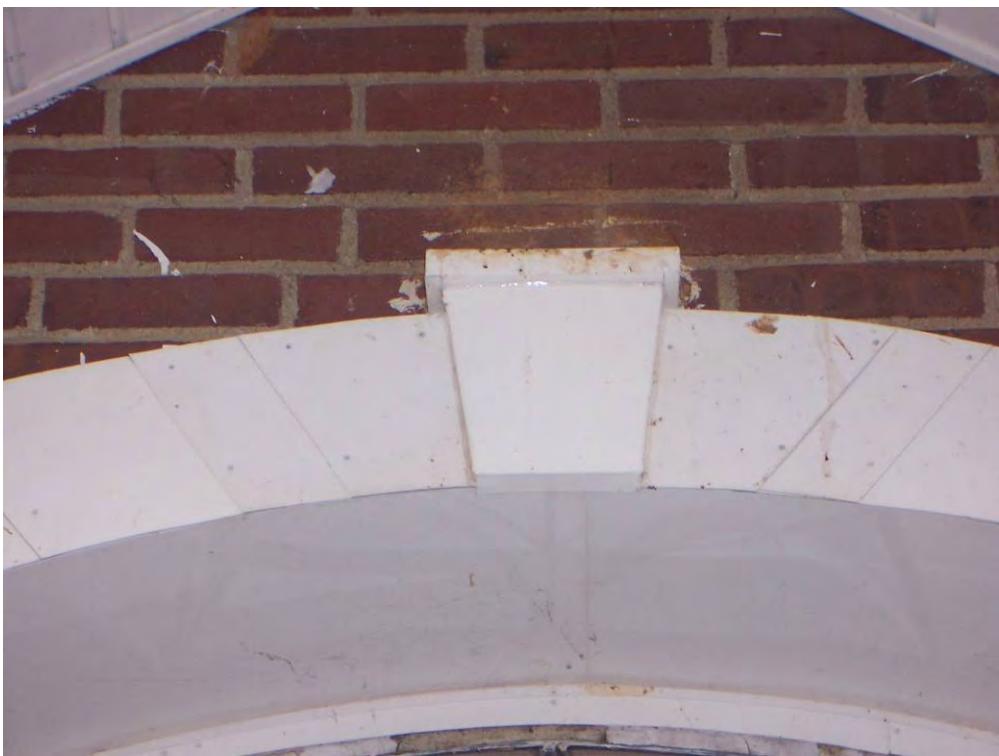
Figure 21. Aluminum covering of elliptical pediment and keystone.

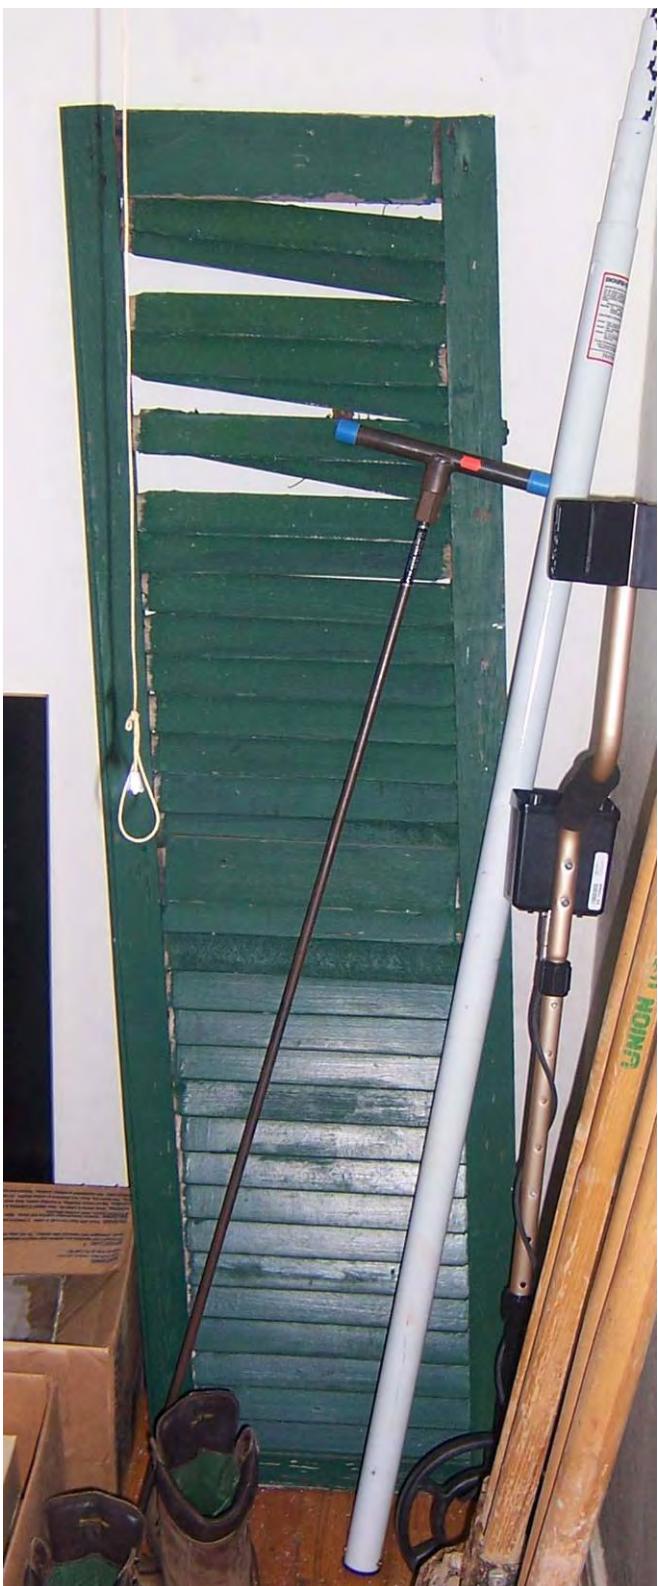
Figure 22. Original shutter found in upstairs bedroom closet.

- Original green shutters are missing and should be replaced in-kind. Please see page 24 for an image of an original shutter. (This action requires review by a qualified historic architect.)

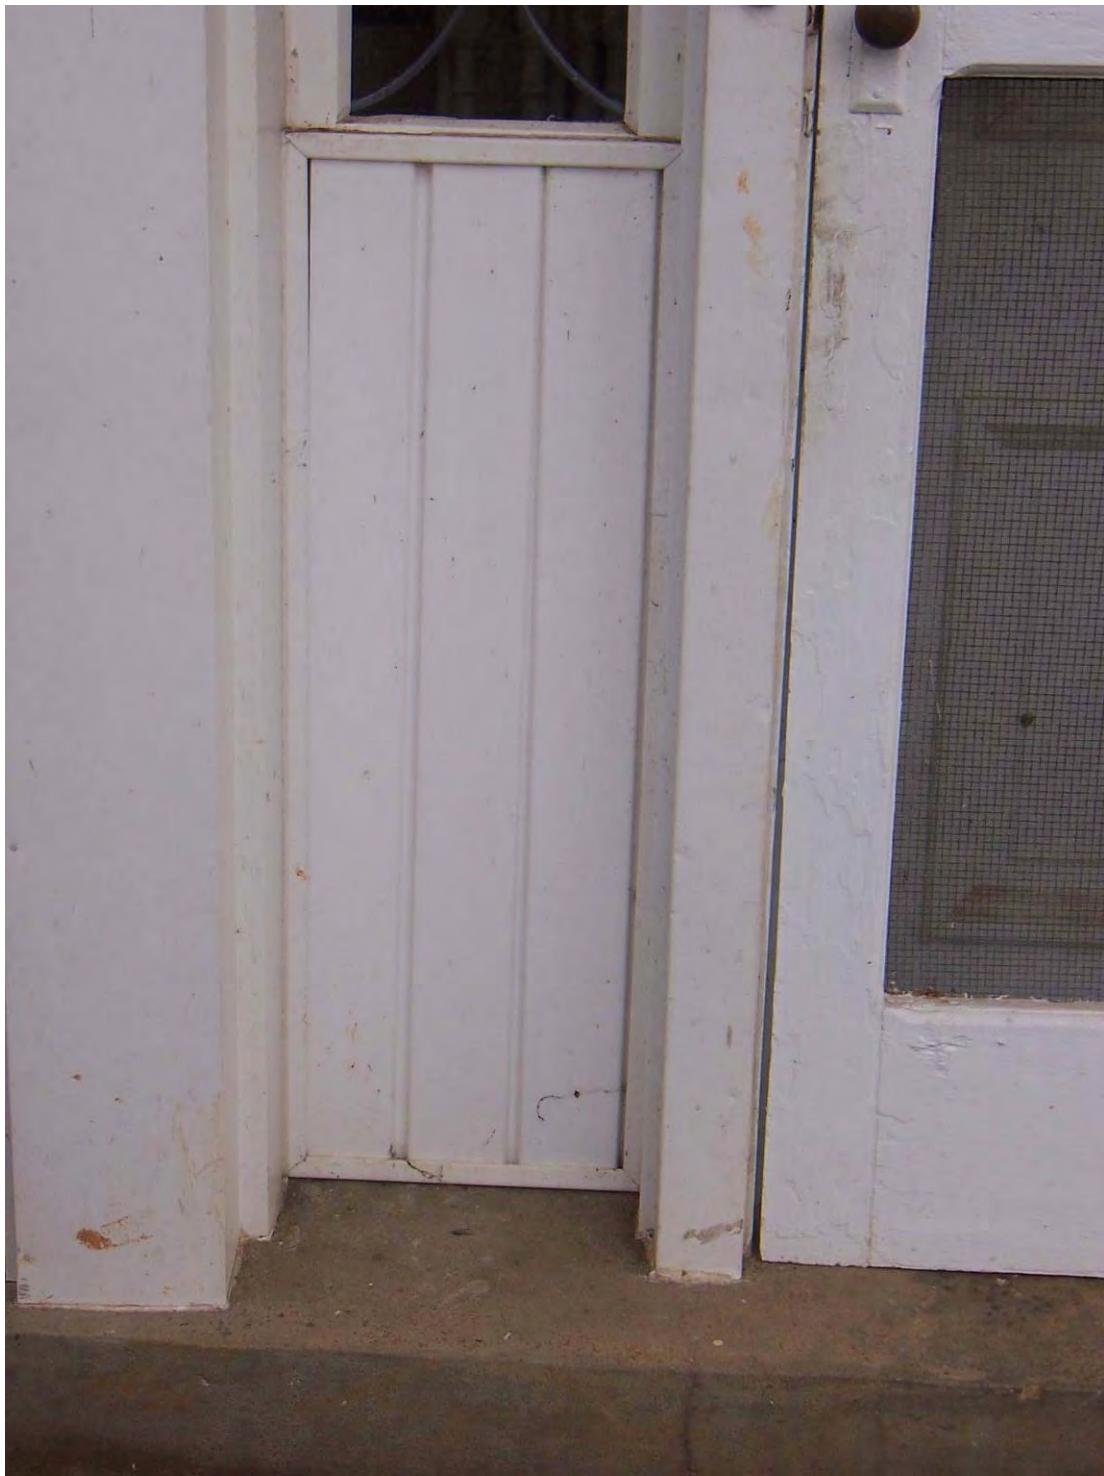
Figure 23. Aluminum covering of sidelight wood panel.

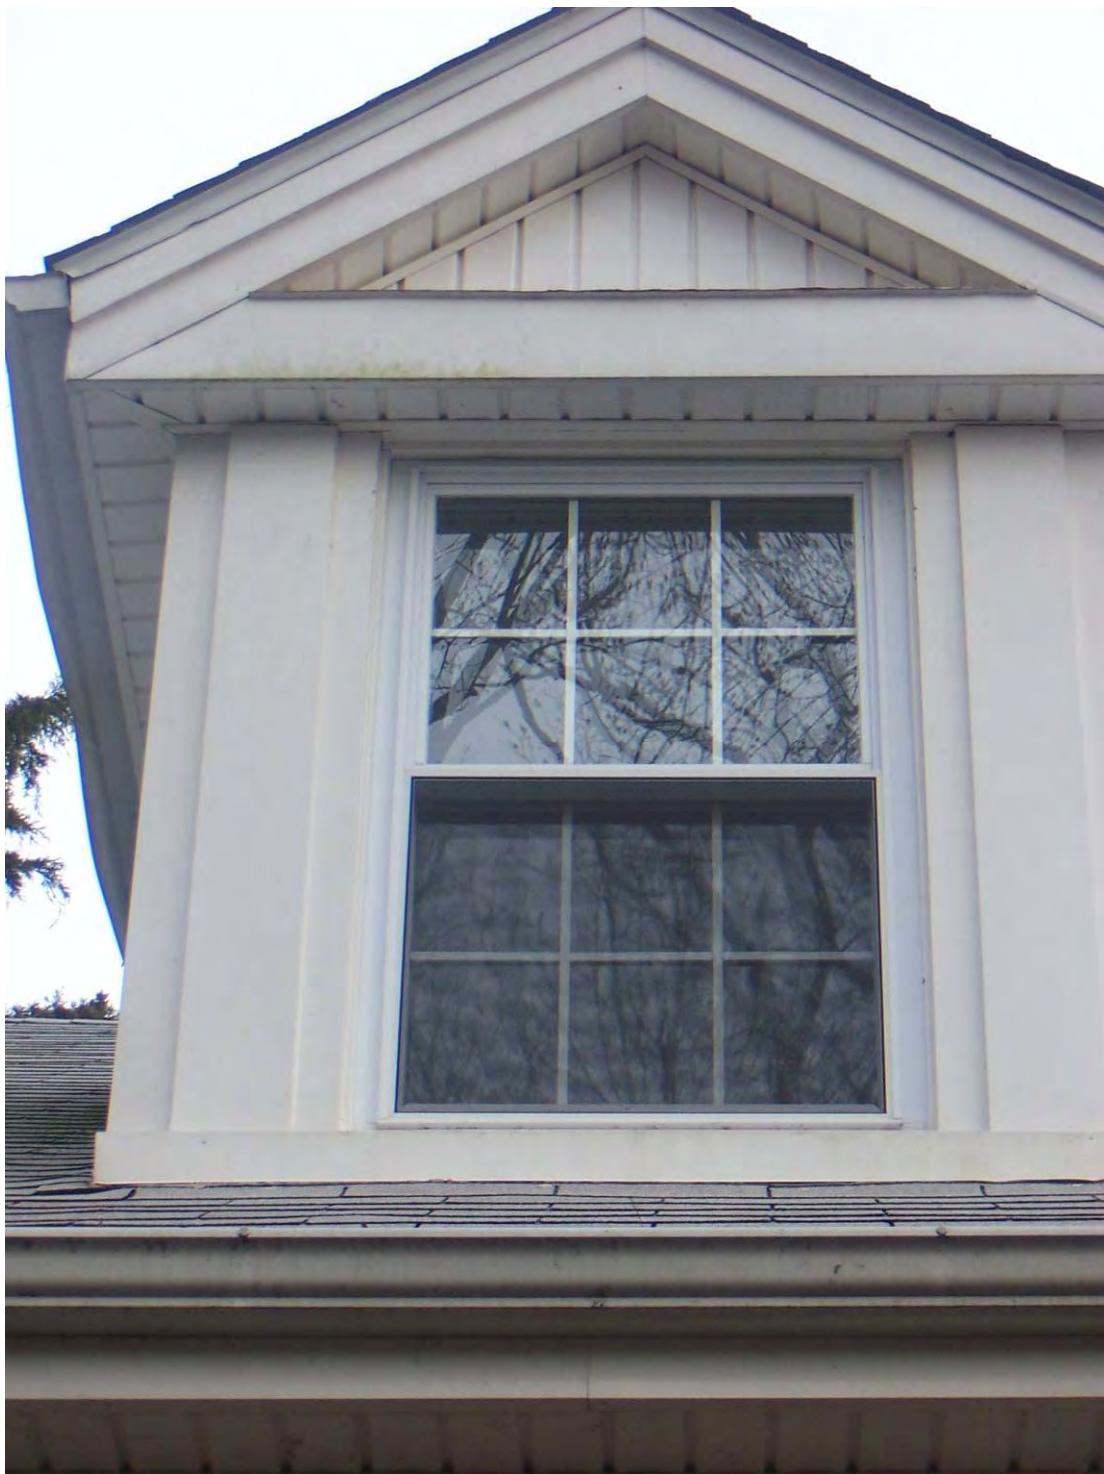
Figure 24. Aluminum covering of pilasters on dormer windows.

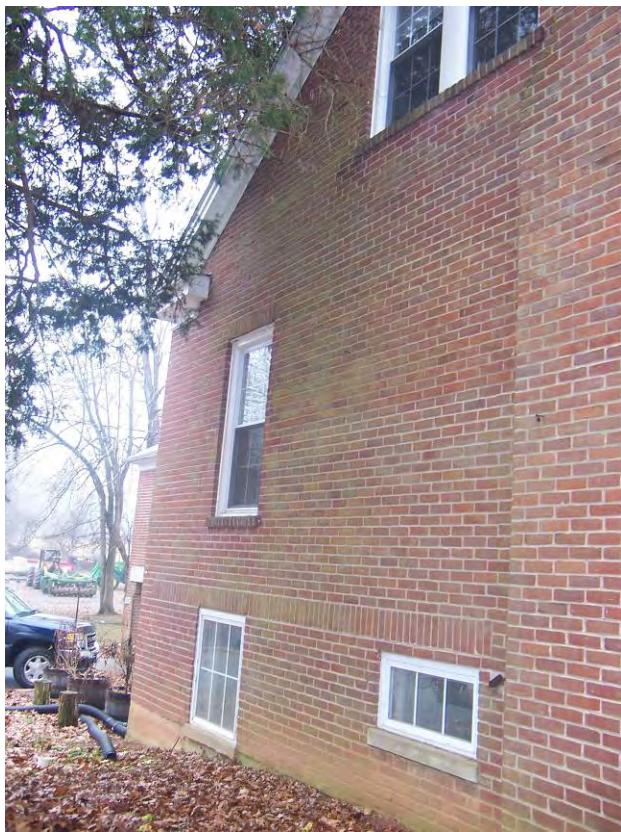
Figure 37. Shade from overgrown cedar tree and fallen leaves lead to lichen growth on north facade.

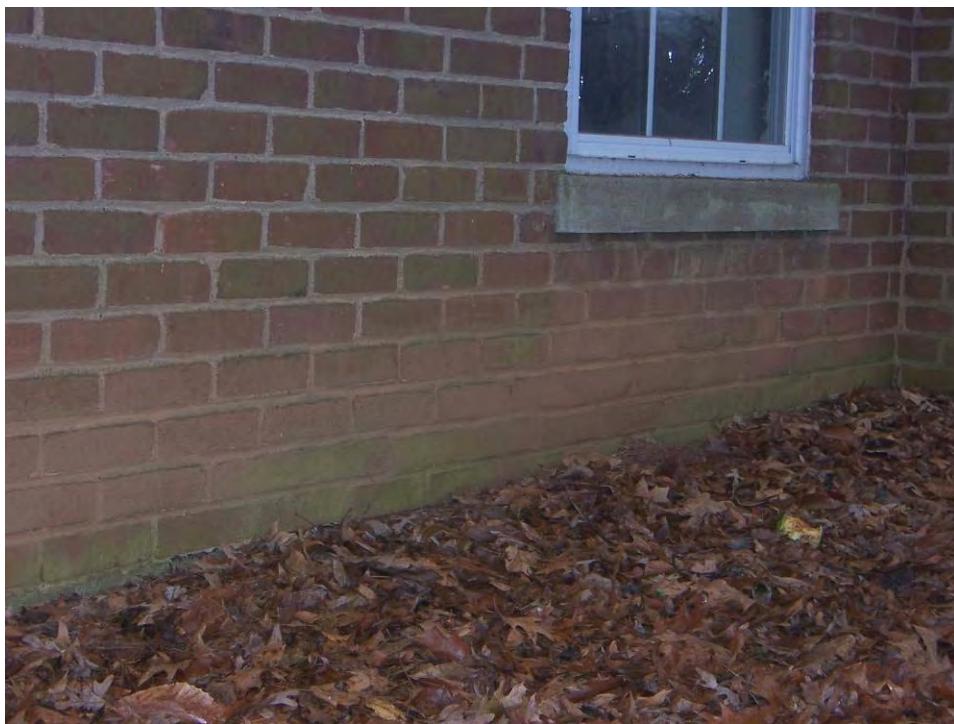
Figure 38. Closeup of lichen growth on north facade near chimney.

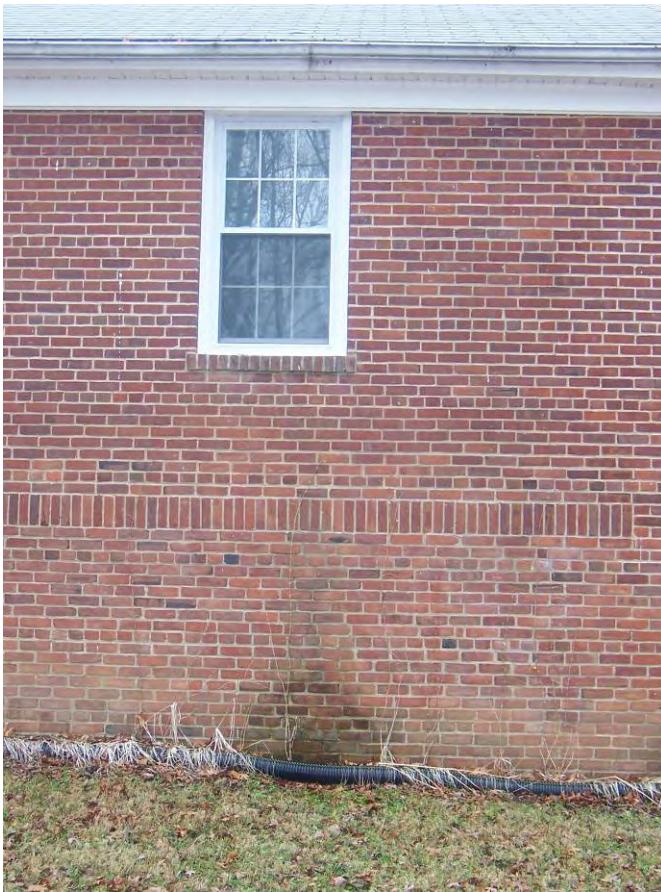
Figure 39. Leaky gutter with wet bricks and mortar on south facade of kitchen addition.

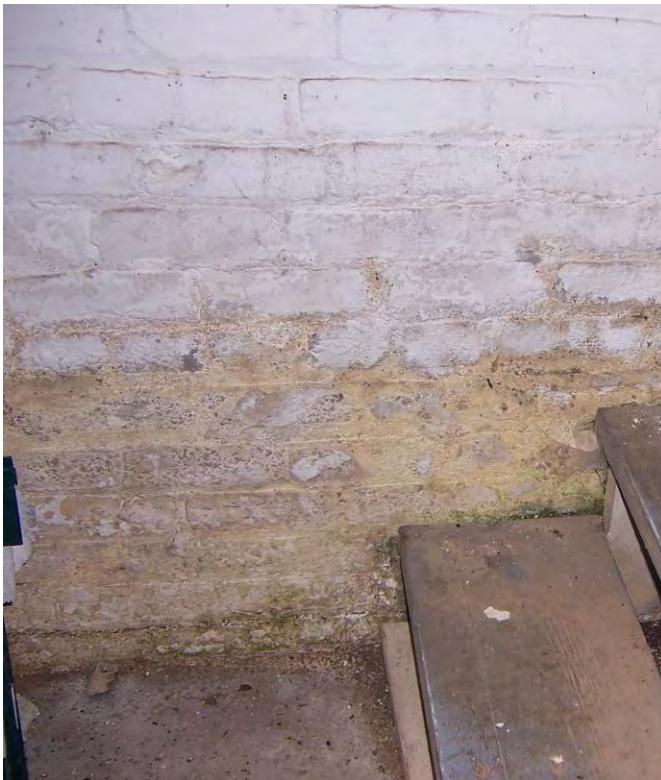
Figure 40. Water damaged painted bricks in the basement near central stair.

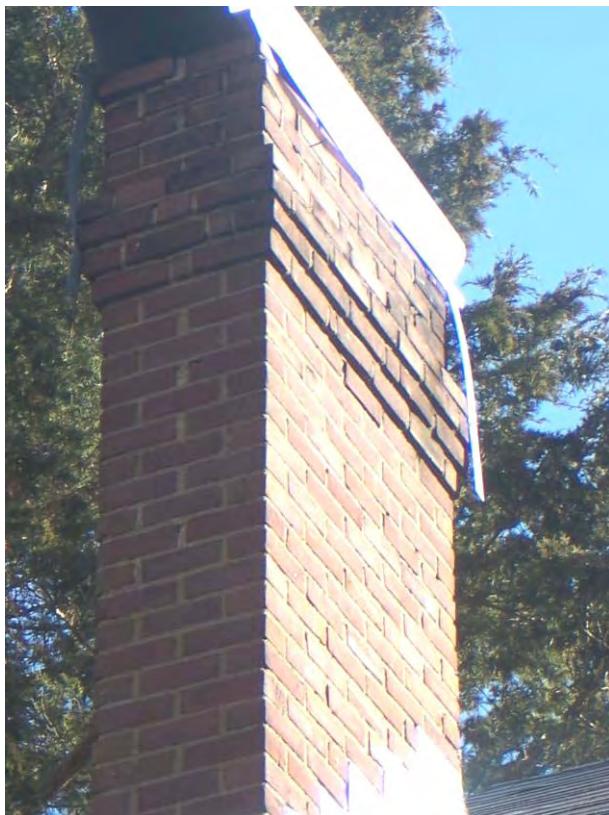
Figure 41. Soot staining, inappropriately repaired brick, and historically inappropriate chimney cap on north chimney.

- Chimneys - remove inappropriate chimney cap on South chimney, clean soot stains on bricks, repair deteriorated mortar, remove mold and lichen growth on chimneys. See pages 50-53 for images that show specific problem areas.

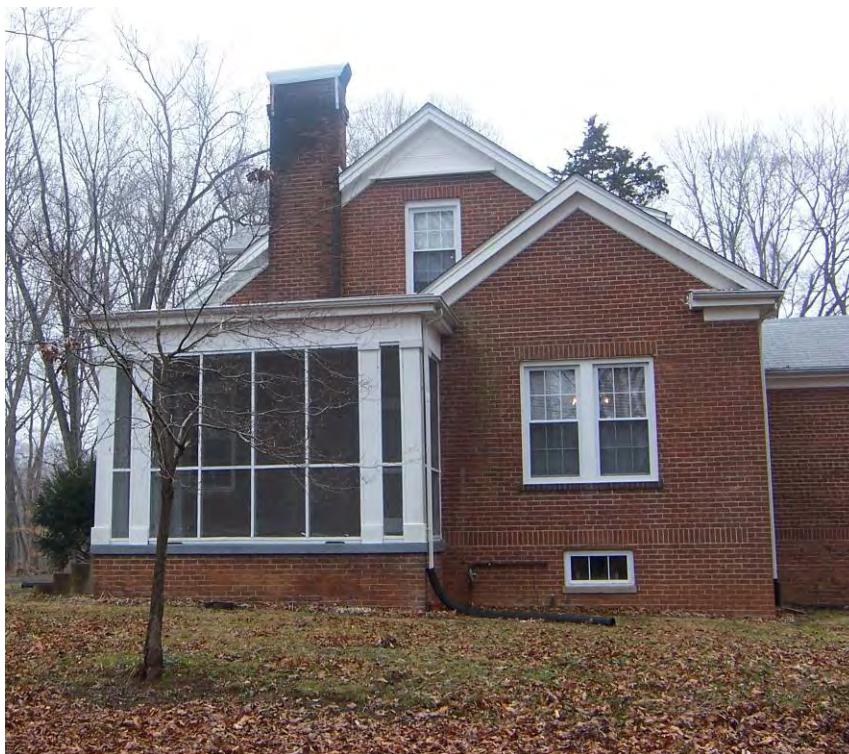
Figure 42. Soot staining and inappropriate chimney cap on south chimney.

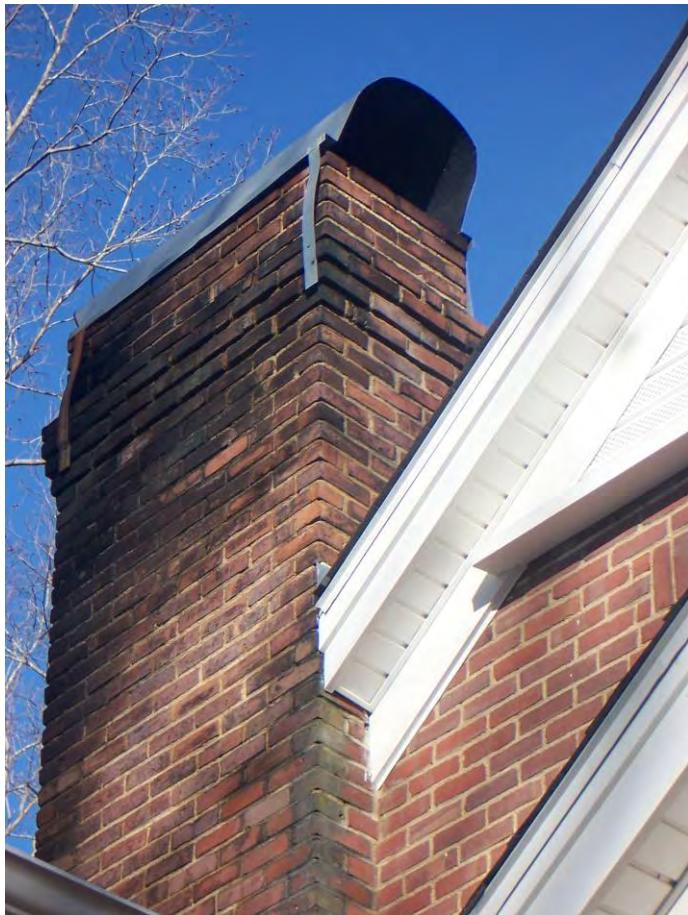
Figure 43. Closeup of soot staining and inappropriate chimney cap on south chimney.

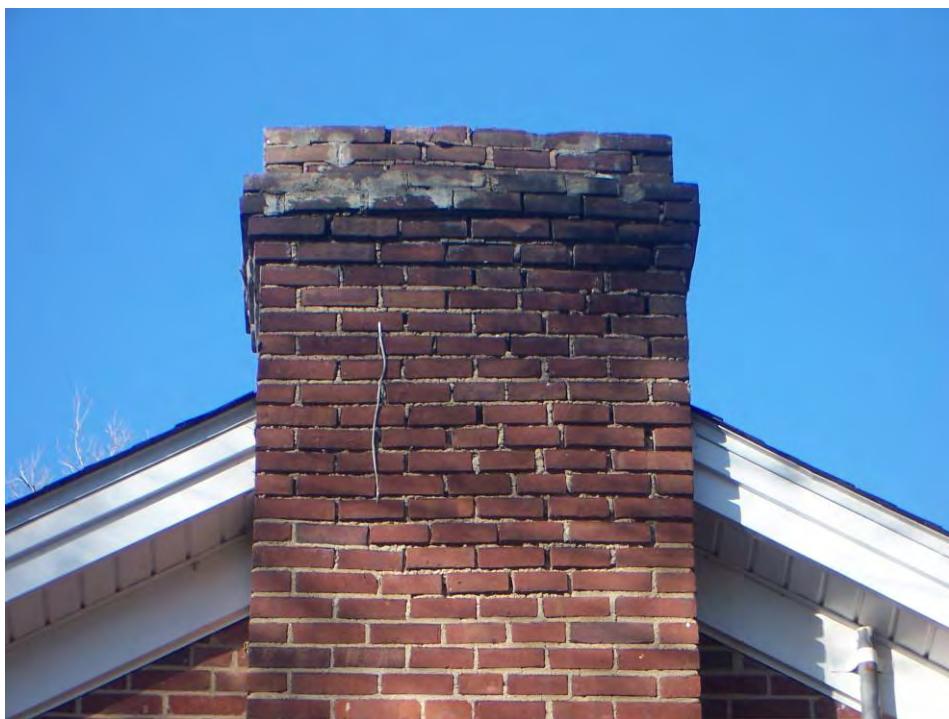
Figure 44. Soot staining, deteriorated mortar, and inappropriate brick reconstruction on kitchen addition chimney.

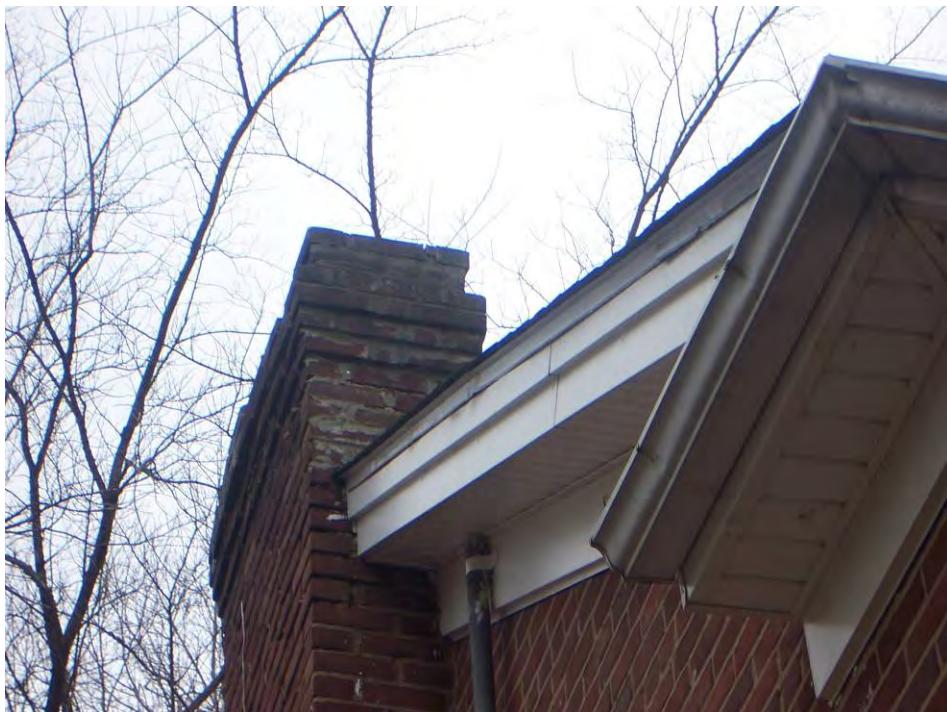
Figure 45. Soot staining, deteriorated mortar, and inappropriate brick reconstruction on kitchen addition chimney.

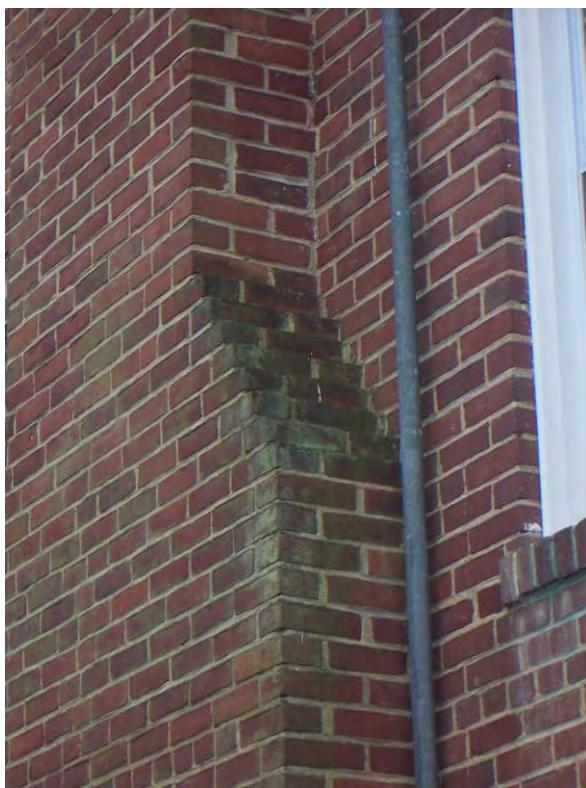
Figure 46. Lichen growth on kitchen addition chimney.

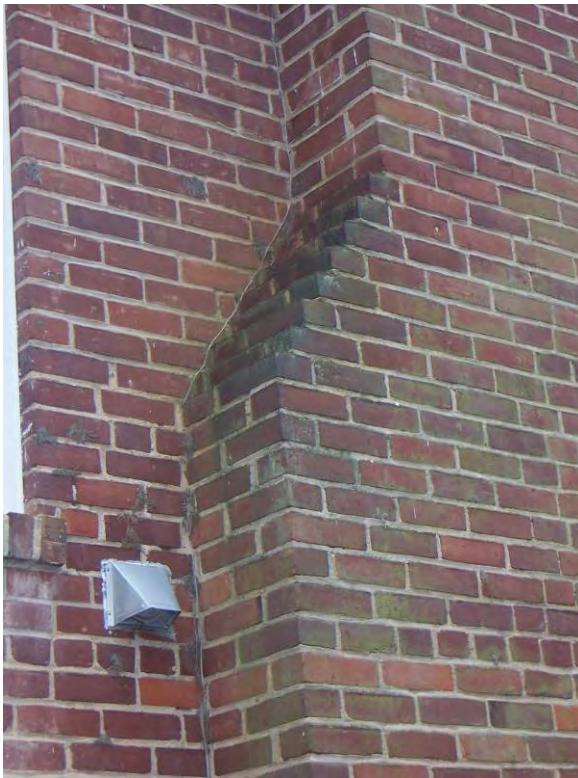
Figure 47. Lichen growth on kitchen addition chimney.

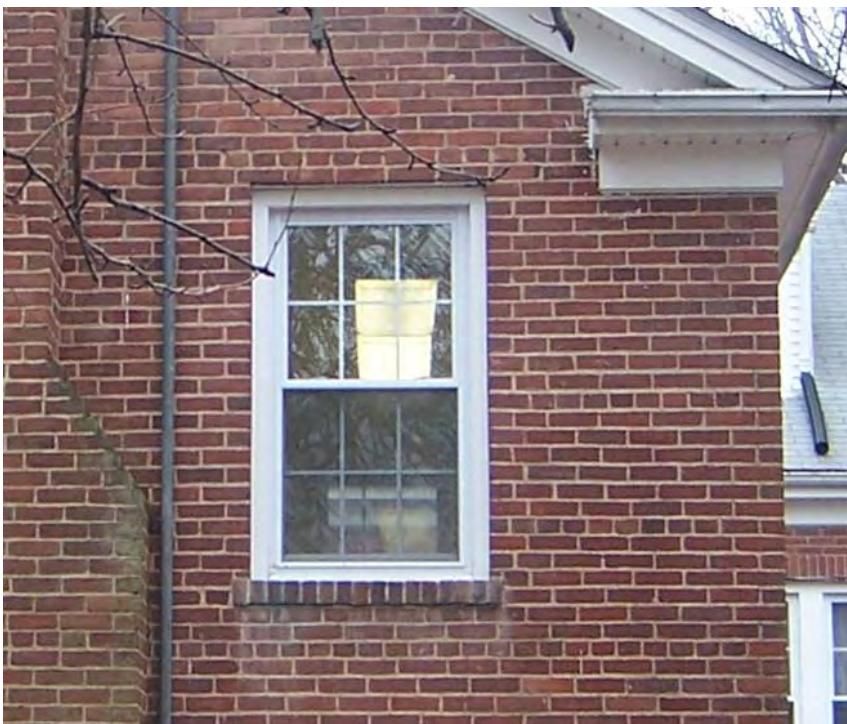
Figure 48. Paint staining below kitchen addition window.

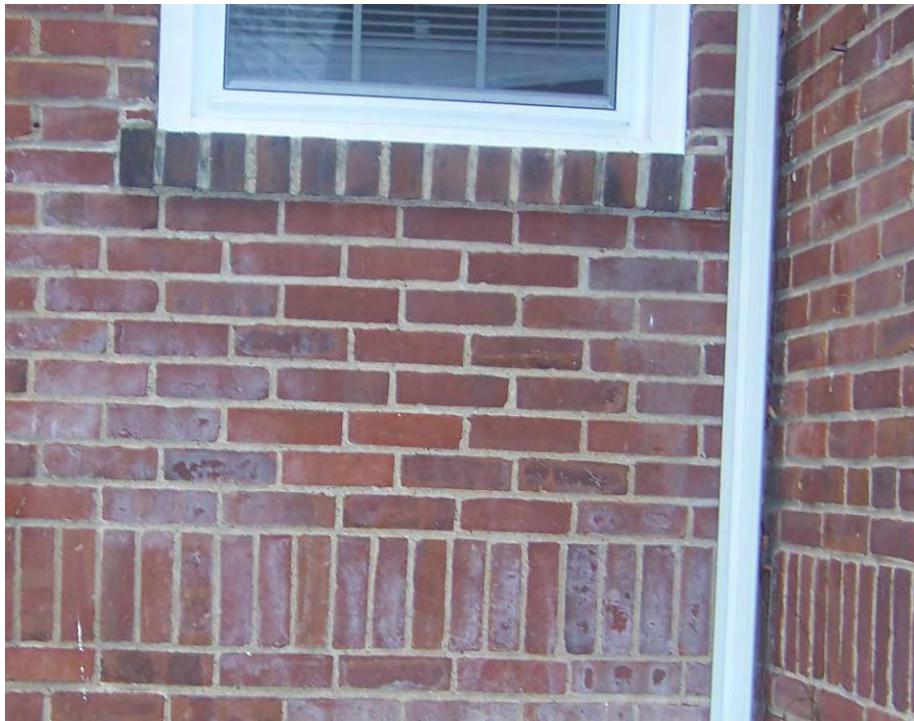
Figure 49. Efflorescence below dining room window.

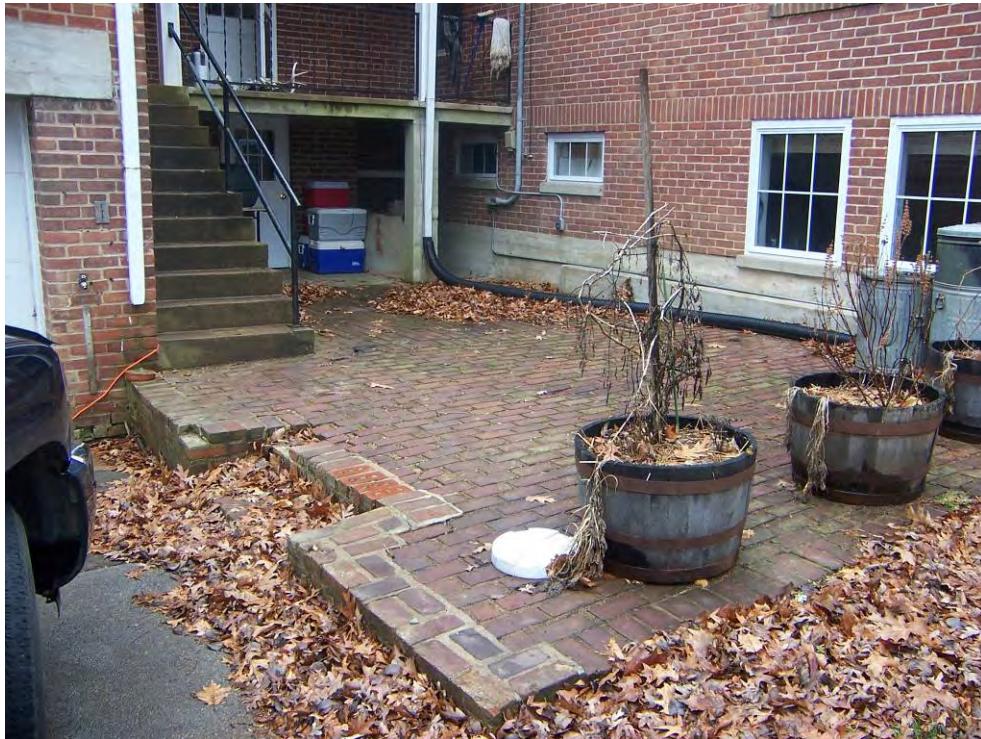
The original kitchen, the hyphen butler's pantry, and the patio are Level 3. Generally, these elements are in good condition and just need annual cleaning. The patio needs to be rebuilt so that water is shed away from the building; however, most of the bricks are in excellent condition and just need to be reset once the patio substructure is accurately constructed.

Figure 50. Overall view of brick patio between main house and kitchen addition.

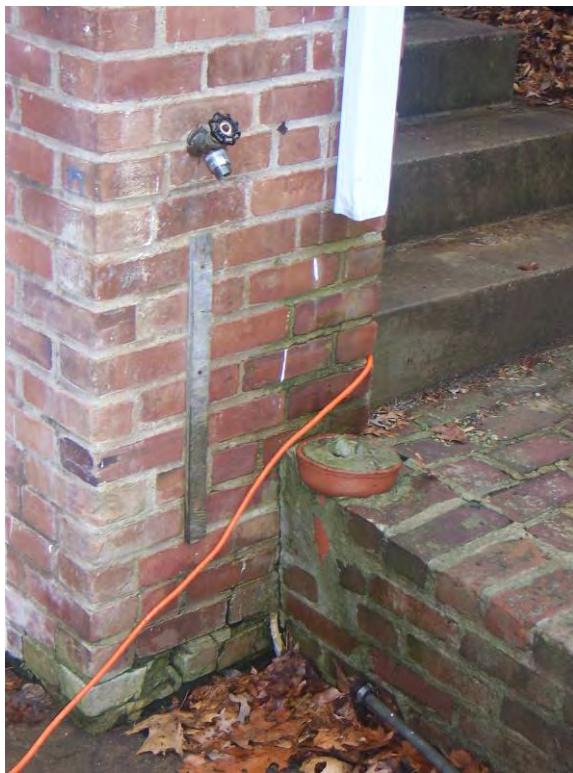
Figure 51. Downspout and spigot that empty onto patio promoting lichen growth and damage to mortar, also inappropriate mortar patch.

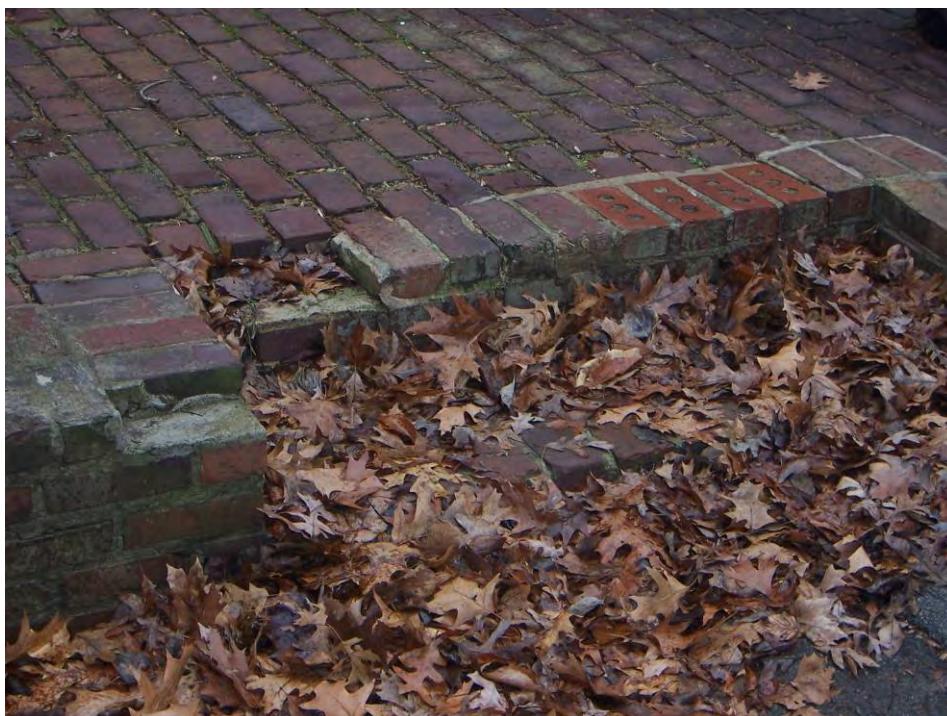
Figure 52. Missing bricks and fallen leaves on brick step to patio.

- Patio - needs to be rebuilt so that water is shed away from the building; however, most of the bricks are in excellent condition and just need to be reset once the patio substructure is accurately constructed. Please see pages 54-57 for images and more information on the patio. (SHPO should review plans for patio reconstruction.)

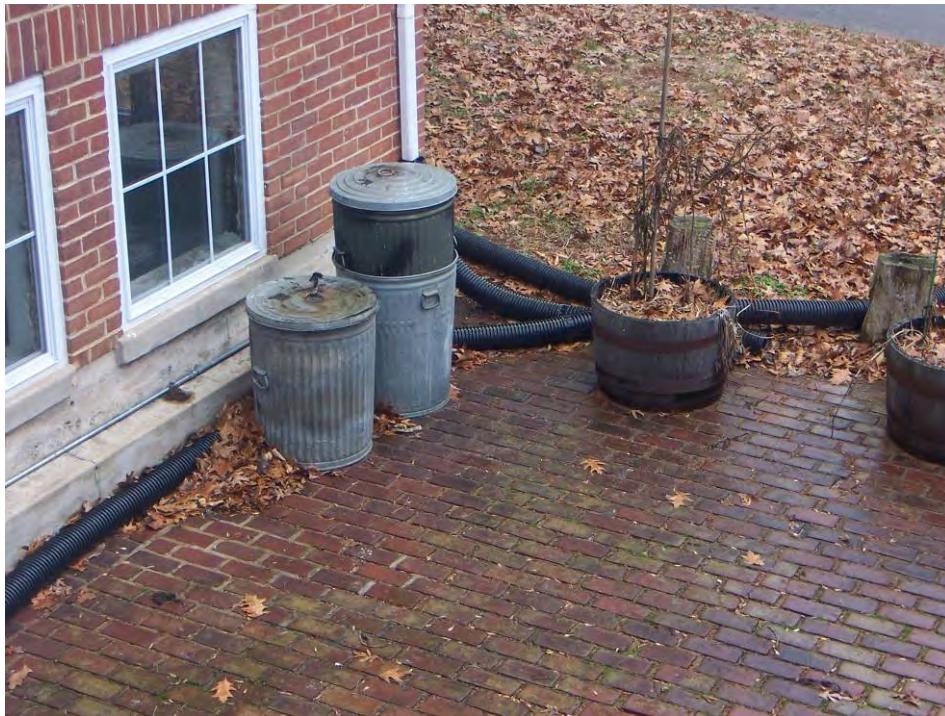
Figure 53. Overall lichen growth on patio.

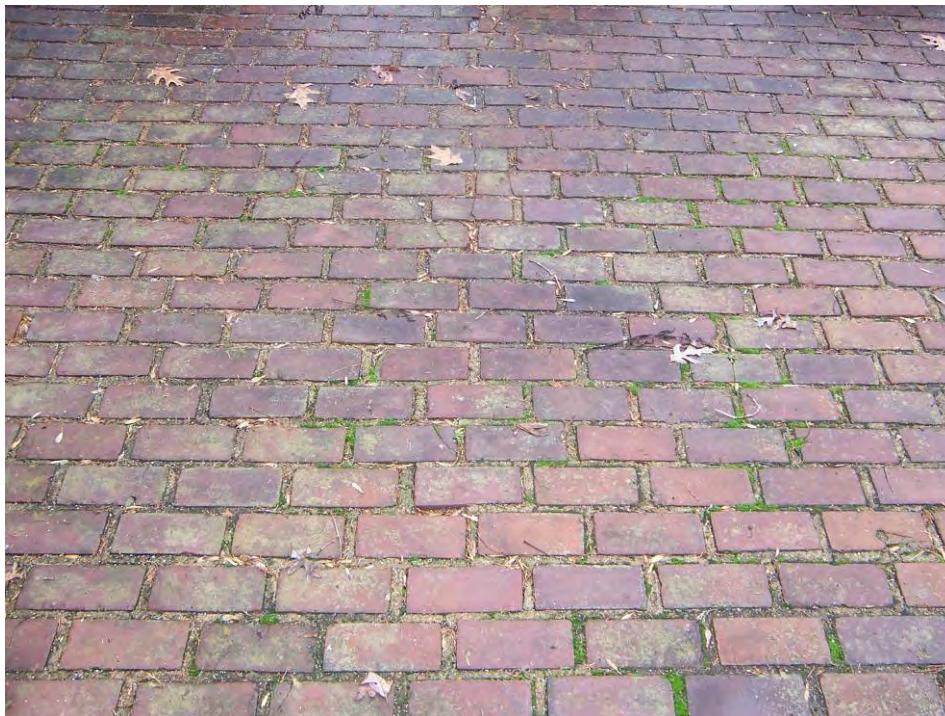
Figure 54. Closeup of lichen growth on patio.

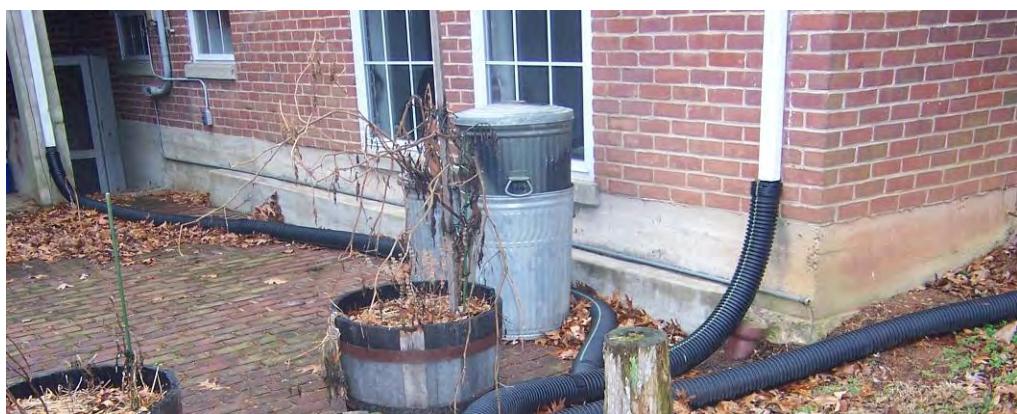
Figure 55. Example of concrete foundation on northeast corner.

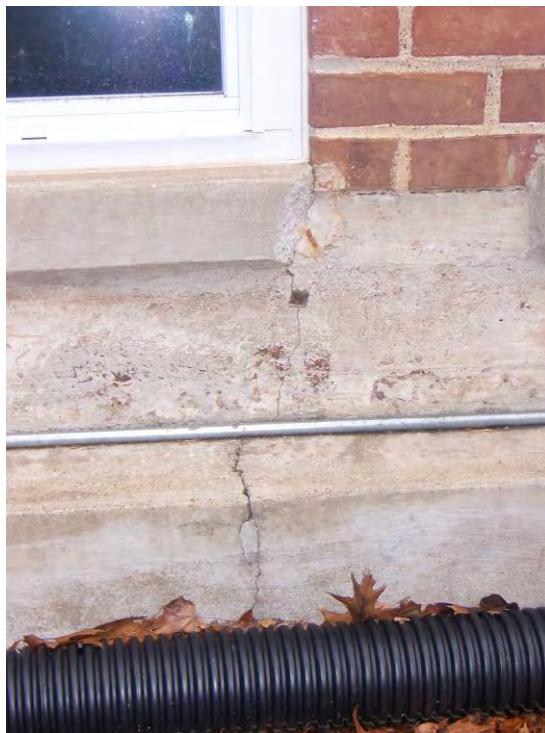
Figure 56. Closeup of crack through concrete foundation.

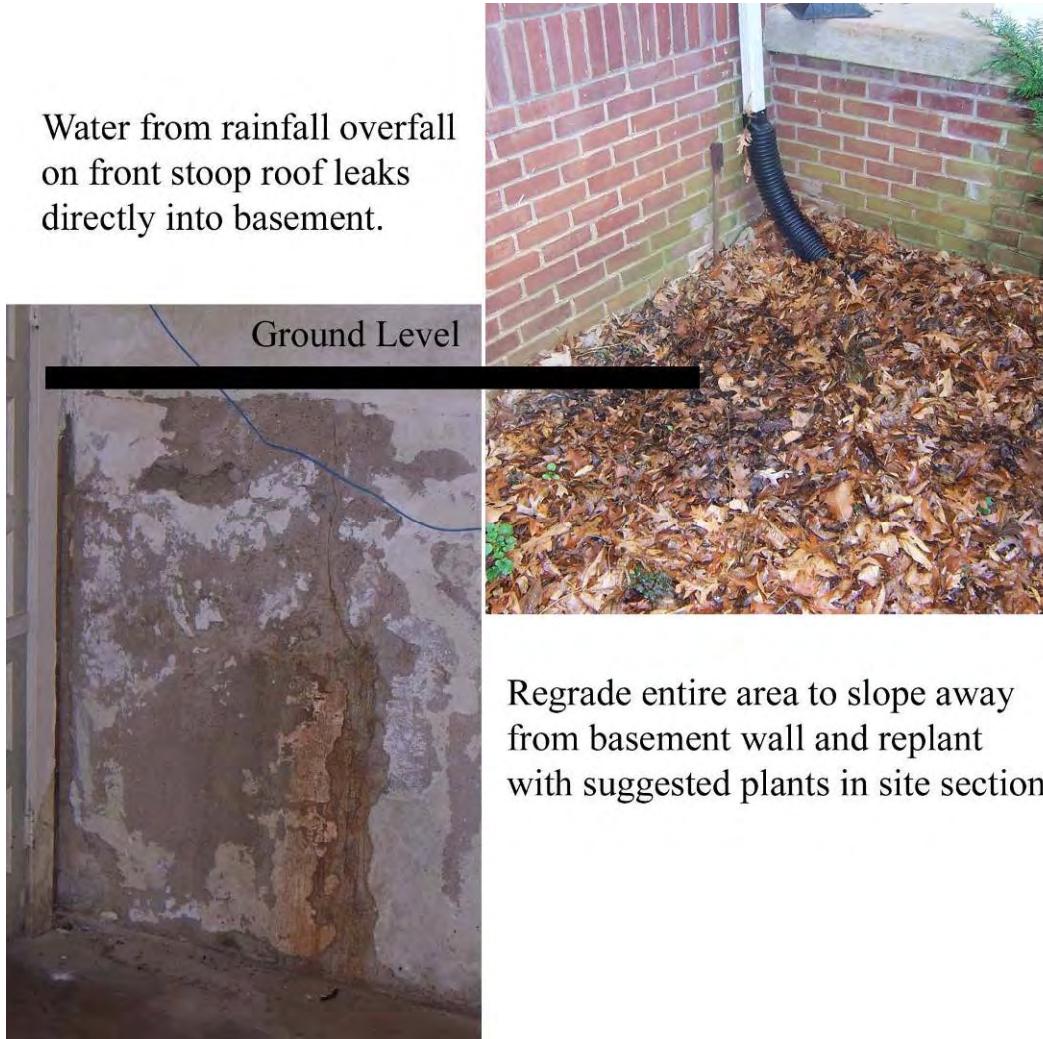
The problems with spalling and water leakage in the basement are directly attributed to gutter/downspout and shrub roots.

Figure 57. Crack and spalling on east side of basement wall in northwest room is due to water infiltrating from point marked in photo.

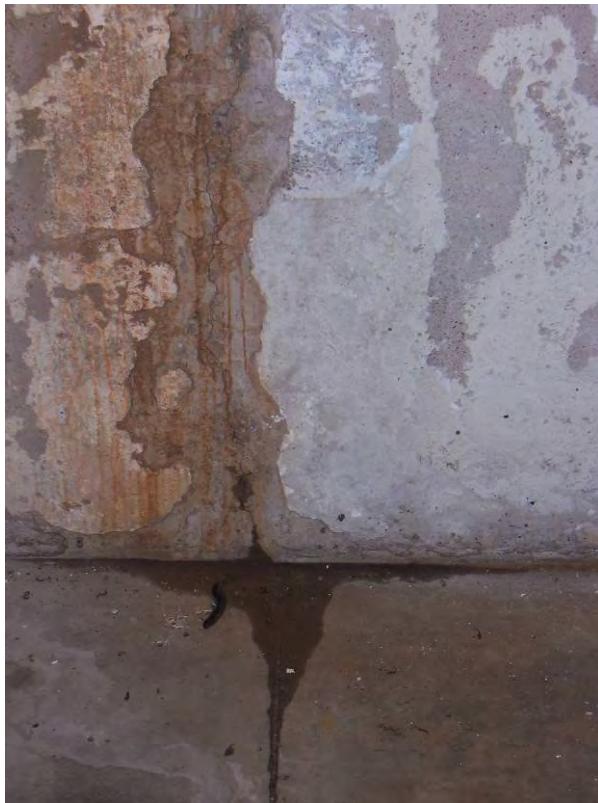
Figure 58. Water leaking into basement on east side crack after storm.

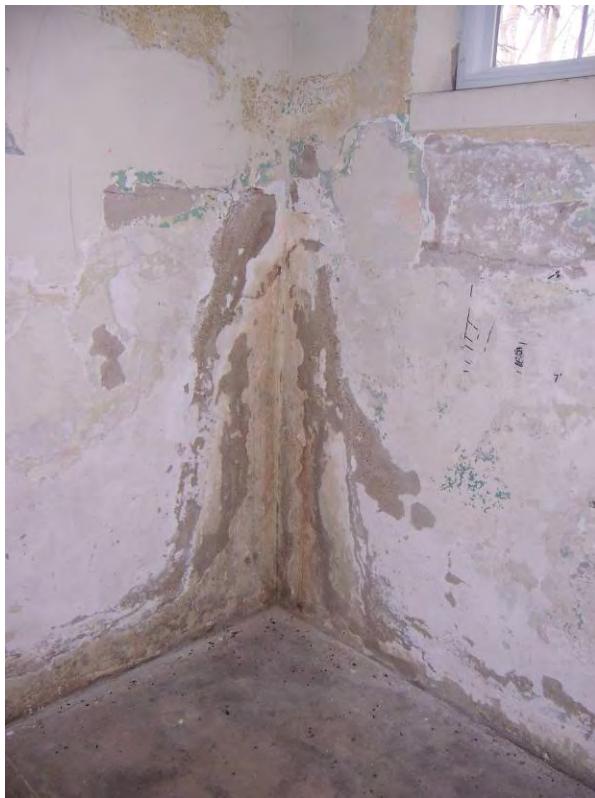
Figure 59. Northwest corner of northwest room in basement.

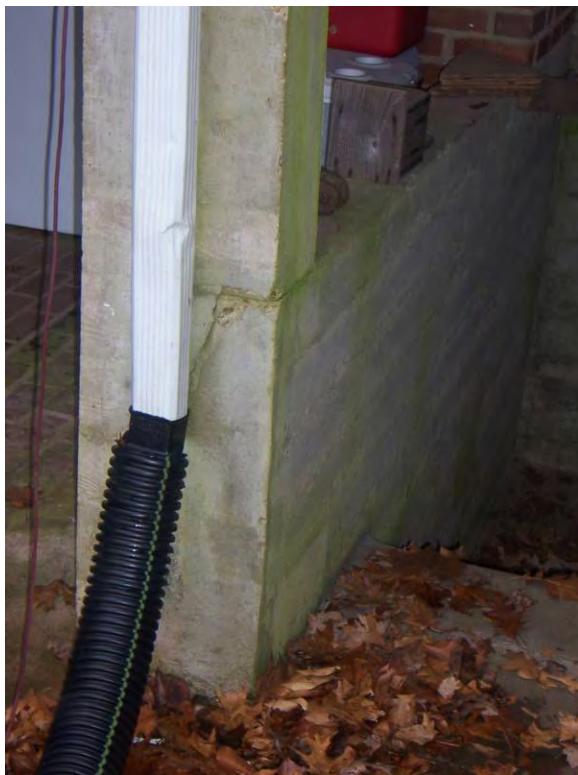
Figure 60. Concrete wall and concrete support pier with crack and lichen growth.

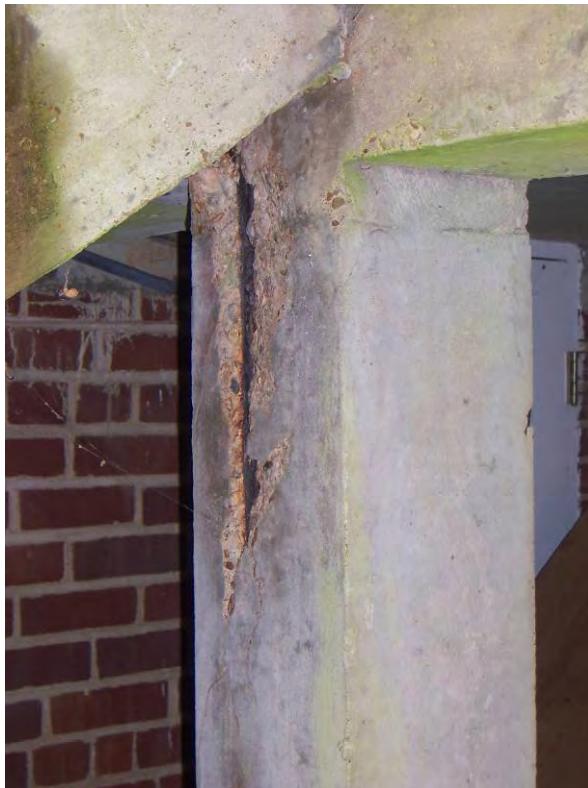
Figure 61. Closeup of spalled concrete pier with rebar subjected to weather.

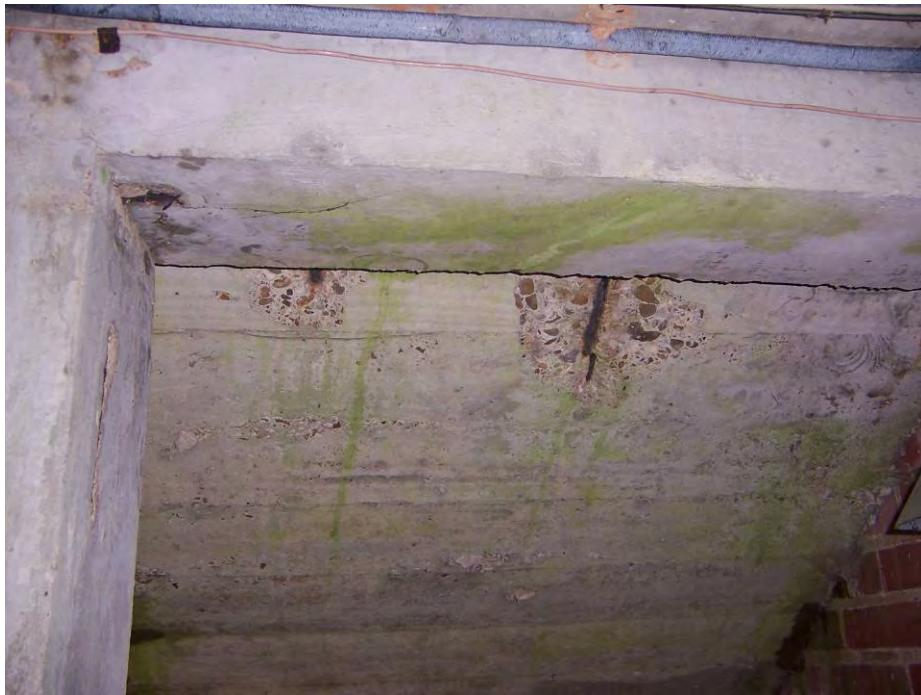
Figure 62. Closeup of backside of concrete stairs with spalled concrete and rebar subjected to weather.
